**Flood Control Project Maintenance
Levee Inspections**

Maintenance Issue Types Only, Levee Inspection Report By Mile - Spring 2019

Reclamation District No. 0150 Merrit Island

Waterway	Bank	Unit Miles	Inspection Start/End	Inspector
Unit No. 01 Sutter Slough	Left	0.52	04/12/2019 04/12/2019	Luz Dial

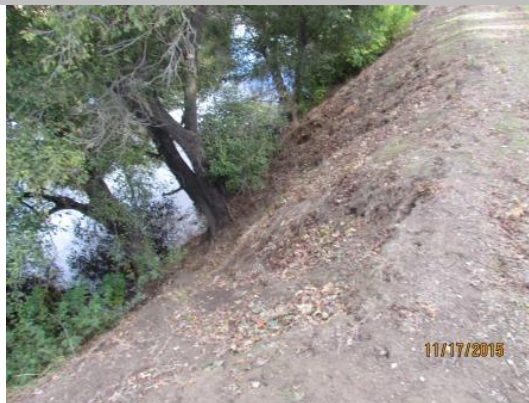
Photo 1 of 1 : SP_2019_RD0150_17_65_20190307_00053.jpg

LM Start	8.26	Rating **	M	Issue No.	65
LM End	8.26	Issue Type +	Ma	Location *	WS
Category	Earthen Levee			GPS Latitude/Longitude	
				Start	End
Item	Erosion / Bank Caving			38.408213 °	38.408213 °
				-121.535911 °	-121.535911 °
DWR ID	DWR_RD0150_03_f_2015_65				
Comment Code					
E2 : Schedule repair of erosion site prior to the next inspection.					
Inspector Comment

View of erosion on the waterside of the levee. Fall 2015

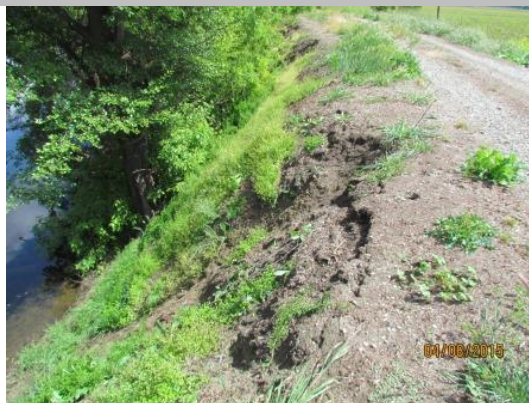
Photo 1 of 1 : SP_2019_RD0150_17_66_20190307_00054.jpg

LM Start	8.31	Rating **	M	Issue No.	66
LM End	8.31	Issue Type +	Ma	Location *	WS
Category	Earthen Levee			GPS Latitude/Longitude	
				Start	End
Item	Erosion / Bank Caving			38.407960 °	38.407960 °
				-121.534898 °	-121.534898 °
DWR ID	DWR_RD0150_03_s_2012_66				
Comment Code					
E2 : Schedule repair of erosion site prior to the next inspection.					
Inspector Comment

View of erosion on the waterside of the levee. Spring 2015

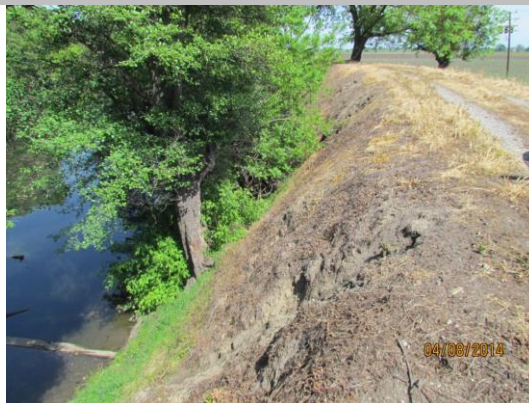
Photo 1 of 2 : SP_2019_RD0150_17_67_20190307_00055.jpg

LM Start	8.33	Rating **	M	Issue No.	67
LM End	8.33	Issue Type +	Ma	Location *	WS
Category	Earthen Levee			GPS Latitude/Longitude	
				Start	End
Item	Erosion / Bank Caving			38.407958 °	38.407958 °
				-121.534583 °	-121.534583 °
DWR ID	DWR_RD0150_03_s_2012_67				
Comment Code					
E2 : Schedule repair of erosion site prior to the next inspection.					
Inspector Comment

View of the erosion on the waterside shoulder looking upstream during spring 2014 inspection.

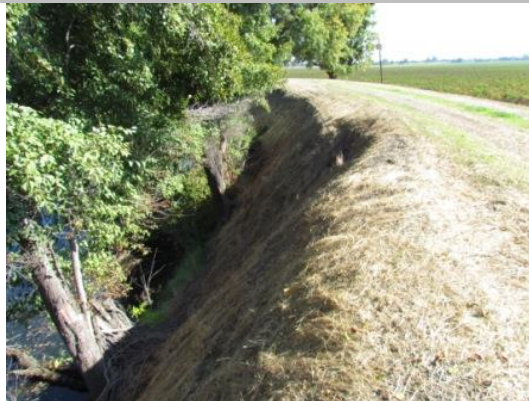
Photo 2 of 2 : SP_2019_RD0150_17_67_20190307_00056.jpg

LM Start	8.33	Rating **	M	Issue No.	67 (cont)	
LM End	8.33	Issue Type +	Ma	Location *	WS	
Category	Earthen Levee			GPS Latitude/Longitude		
				Start		End
Item	Erosion / Bank Caving			38.407958 °	38.407958 °	
				-121.534583 °	-121.534583 °	
DWR ID	DWR_RD0150_03_s_2012_67					
Comment Code						
E2 : Schedule repair of erosion site prior to the next inspection.						
Inspector Comment

Erosion was found on the waterside shoulder of the levee looking upstream. This picture was taken during fall 2012 inspection.

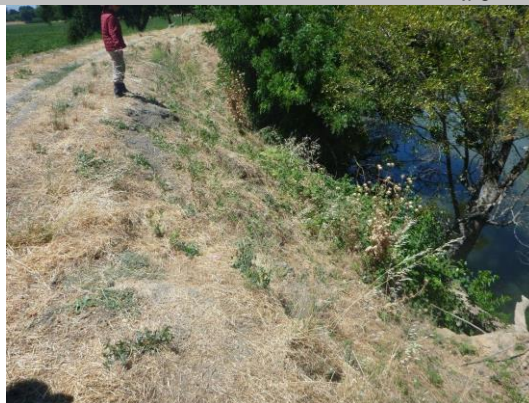
Photo 1 of 3 : LEVAL_SP_2019_316_2180.jpg

LM Start	8.35	Rating **	A/W	Issue No.	123
LM End	8.35	Issue Type +	Ma	Location *	WS
Category	Supplemental		GPS Latitude/Longitude		
			Start	End	
Item	2017 Storm Damage		38.407983 °	38.407992 °	
			-121.534322 °	-121.534289 °	
DWR ID	DWR_RD0150_03_f_2017_123				
Comment Code					
Inspector Comment					
<p>Levee Evaluation Comments</p> <p>Description: Erosion was observed on the waterside levee slope on the east (left) bank of Elk Slough. The site is approximately 10 feet long. See attached pages for photos.</p> <p>Site ID No:316</p> <p>Site Designation:LMA-143</p> <p>Repair Type: Erosion</p> <p>Rating: Serious</p> <p>Field Date:7/17/2017</p> <p>Notes: 3 large trees in/adjacent to site including a fallen tree in the middle of the erosion. Erosion on almost the whole slope, but doesn't cut into the crown. Serious because erosion cuts into levee significantly here.</p>

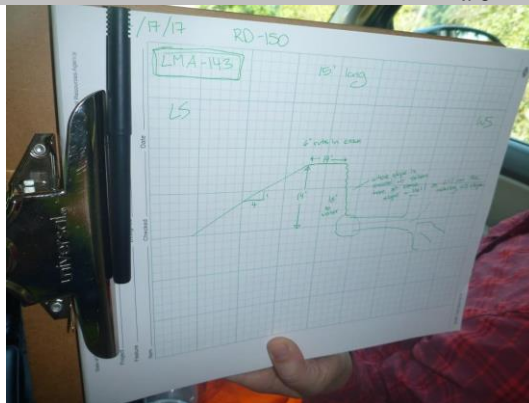
Photo 3 of 3 : LEVAL_SP_2019_316_2182.jpg

LM Start	8.35	Rating **	A/W	Issue No.	123 (cont)
LM End	8.35	Issue Type +	Ma	Location *	WS
Category	Supplemental			GPS Latitude/Longitude	
				Start	End
Item	2017 Storm Damage			38.407983 °	38.407992 °
				-121.534322 °	-121.534289 °
DWR ID	DWR_RD0150_03_f _ 2017_123				
Comment Code					
Inspector Comment					
Levee Evaluation Comments					
Description: Erosion was observed on the waterside levee slope on the east (left) bank of Elk Slough. The site is approximately 10 feet long. See attached pages for photos.					
Site ID No:316					
Site Designation:LMA-143					
Repair Type: Erosion					
Rating: Serious					
Field Date:7/17/2017					
Notes: 3 large trees in/adjacent to site including a fallen tree in the middle of the erosion. Erosion on almost the whole slope, but doesn't cut into the crown. Serious because erosion cuts into levee significantly here.

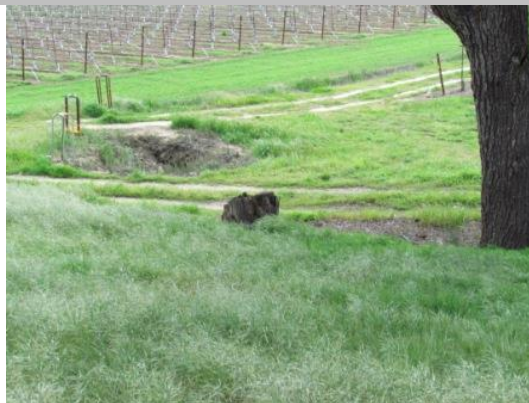
Photo 1 of 1 : SP_2019_RD0150_17_90_20190307_00073.jpg

LM Start	8.46	Rating **	N	Issue No.	90
LM End	8.46	Issue Type +	Ma	Location *	LS
Category	Earthen Levee			GPS Latitude/Longitude	
				Start	End
Item	Trim / Thin Trees			38.409220 °	38.409220 °
				-121.532801 °	-121.532801 °
DWR ID	DWR_RD0150_03_s_2012_90				
Comment Code					
T5 : Tree stumps.					
Inspector Comment

A tree stump was found on the landside of the levee looking upstream.

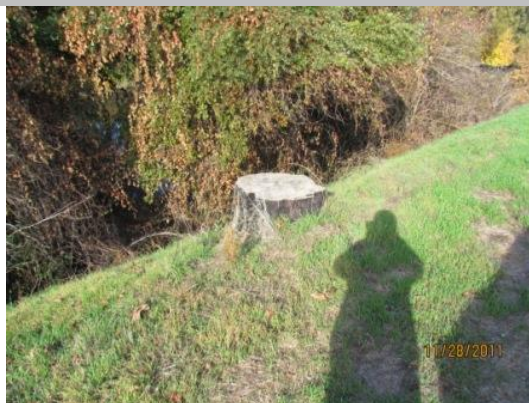
Photo 1 of 1 : SP_2019_RD0150_17_55_20190307_00042.jpg

LM Start	8.50	Rating **	N	Issue No.	55
LM End	8.50	Issue Type +	Ma	Location *	WS
Category	Earthen Levee			GPS Latitude/Longitude	
				Start	End
Item	Trim / Thin Trees			38.409559 °	38.409559 °
				-121.532356 °	-121.532356 °
DWR ID	DWR_RD0150_03_s_2012_55				
Comment Code					
T5 : Tree stumps.					
Inspector Comment

A tree stump was found on the waterside of the levee looking upstream.
Fall 2011

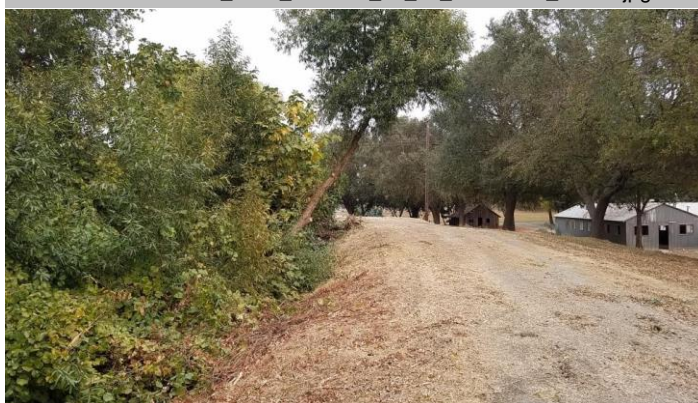
Photo 1 of 3 : SP_2019_RD0150_17_73_20190307_00059.jpg

LM Start	9.31	Rating **	U	Issue No.	73
LM End	9.35	Issue Type +	Ma	Location *	WS
Category	Earthen Levee			GPS Latitude/Longitude	
				Start	End
Item	Trim / Thin Trees			38.413095 °	38.413169 °
				-121.524402 °	-121.523707 °
DWR ID	DWR_RD0150_03_s_2012_73				
Comment Code					
T3 : Trim and thin trees to allow visibility of the ground and room to flood fight.					
Inspector Comment

View of dense vegetation within levee easement. Fall 2018

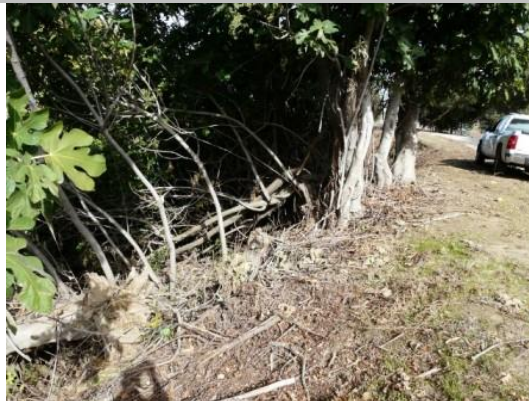
Photo 3 of 3 : SP_2019_RD0150_17_73_20190307_00061.jpg

LM Start	9.31	Rating **	U	Issue No.	73 (cont)	
LM End	9.35	Issue Type +	Ma	Location *	WS	
Category	Earthen Levee			GPS Latitude/Longitude		
				Start		End
Item	Trim / Thin Trees			38.413095 °		38.413169 °
				-121.524402 °		-121.523707 °
DWR ID	DWR_RD0150_03_s_2012_73					
Comment Code						
T3 : Trim and thin trees to allow visibility of the ground and room to flood fight.						
Inspector Comment

Thin/trim trees to allow for visibility of top 20' of waterward slope.
